RICS **Building Survey**...

Date of inspection

18 July 2016

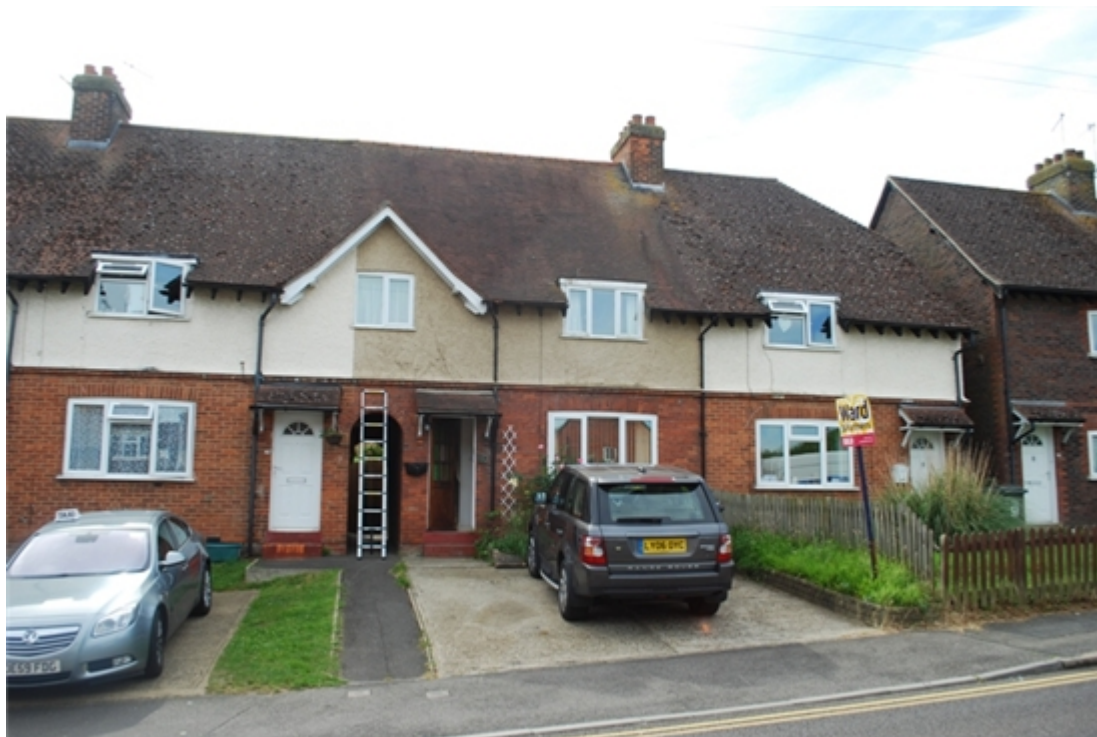
Front elevation.

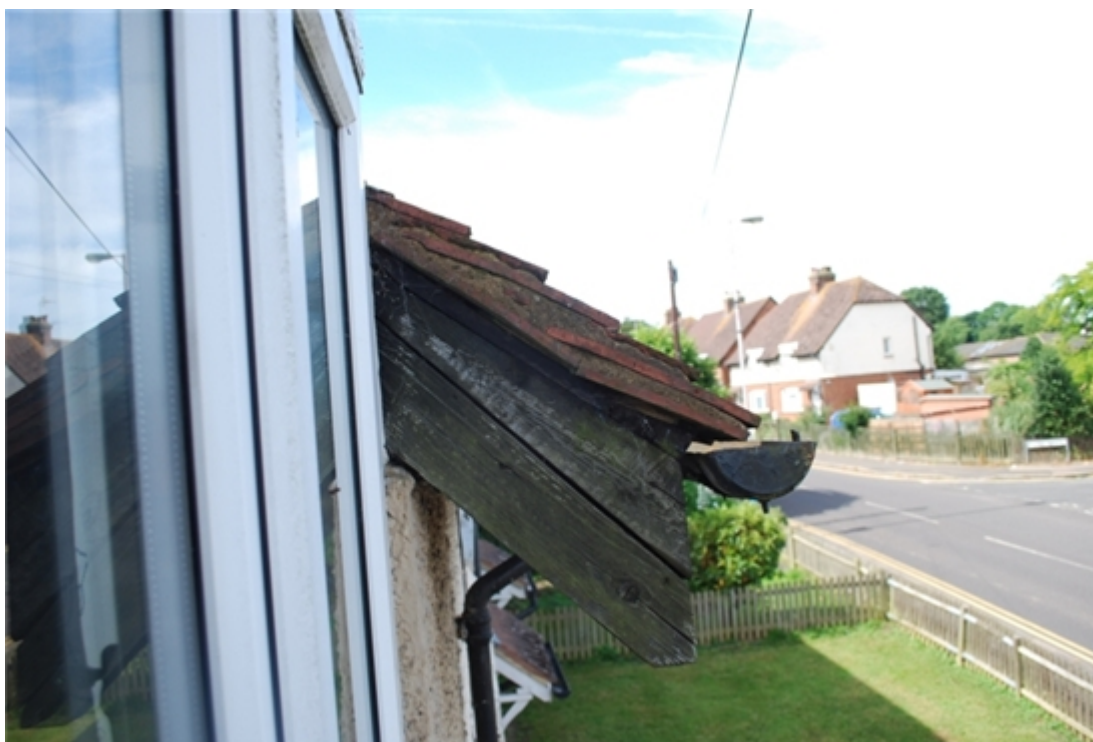
Joist end timber decay. During our inspection we noted that the joist ends were in particularly poor condition having suffered from wet rot timber decay of the ends. On inspection we found that although the damage looks extensive the remaining timber was in fair condition however we could not identify how defective this was further into the sloping soffits of the roof space.

Roof joist decay.

We would recommend that you remove the plaster finish and inspect the top of the wall internally to identify if any further damage has occurred, however we feel it is most likely that damage hasn't occurred and you be able to undertake extensive resin repairs to these timber elements. If we find that the damage is significant internally you have to have a splice repair (or doubled up joists subject to a structural engineer's design) of

the affected timbers this could stretch throughout the whole wall. Note our inspection was only limited to what we could reach from the window safely. The joist ends will require immediate redecoration to prevent further damage.

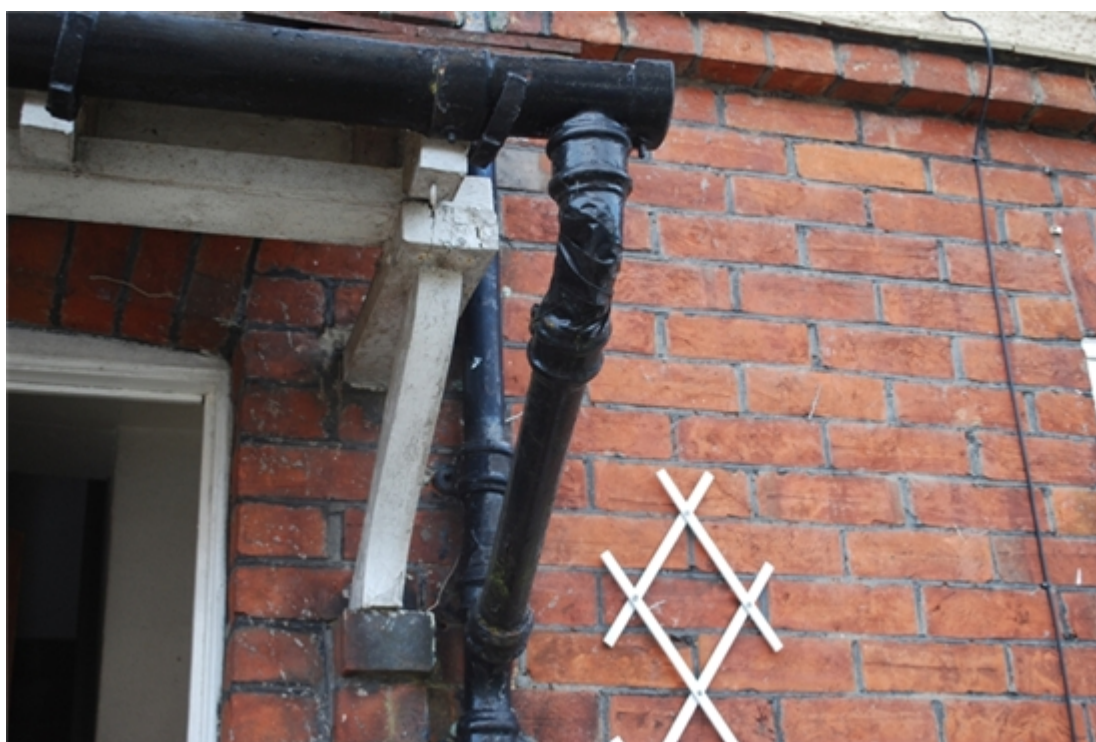
Defective downpipes. Towards the front of the property in close proximity to the front door there is a swan neck type junction, comprising two brackets and a section of downpipe at an angle. This detail contains black gaffer tape as a repair to make them watertight. This is not an approved repair and will leak therefore the sections will need to be removed possibly including for a weld repair in addition to decoration. As before it will be more financially viable to replace these rainwater goods with PVCu. 3

Downpipe taped together.

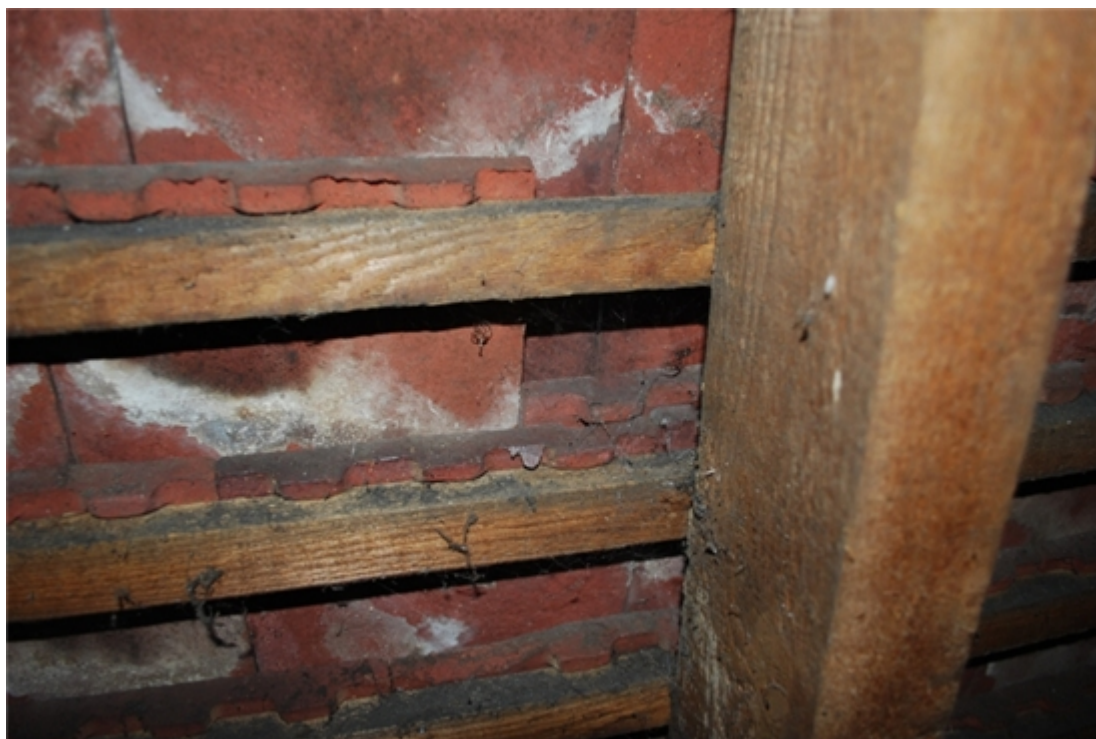
Within the loft space you can see daylight through the tiles where tiles have slipped on battens as noted in section E2. Where you can see daylight remedial works will be required in the form of re-fixing the existing roof tiles. When undertaking this work externally there is a risk that the surrounding roof tiles and may crack or become damaged therefore you should allow for a nominal amount of additional replacements tiles.

Slipped tiles visible in roof space.
